# The Compound Rowhouses

Palimpsest: Layering Thermal Control into an Existing Building

NEW ECOLOGY

QUINN EVANS

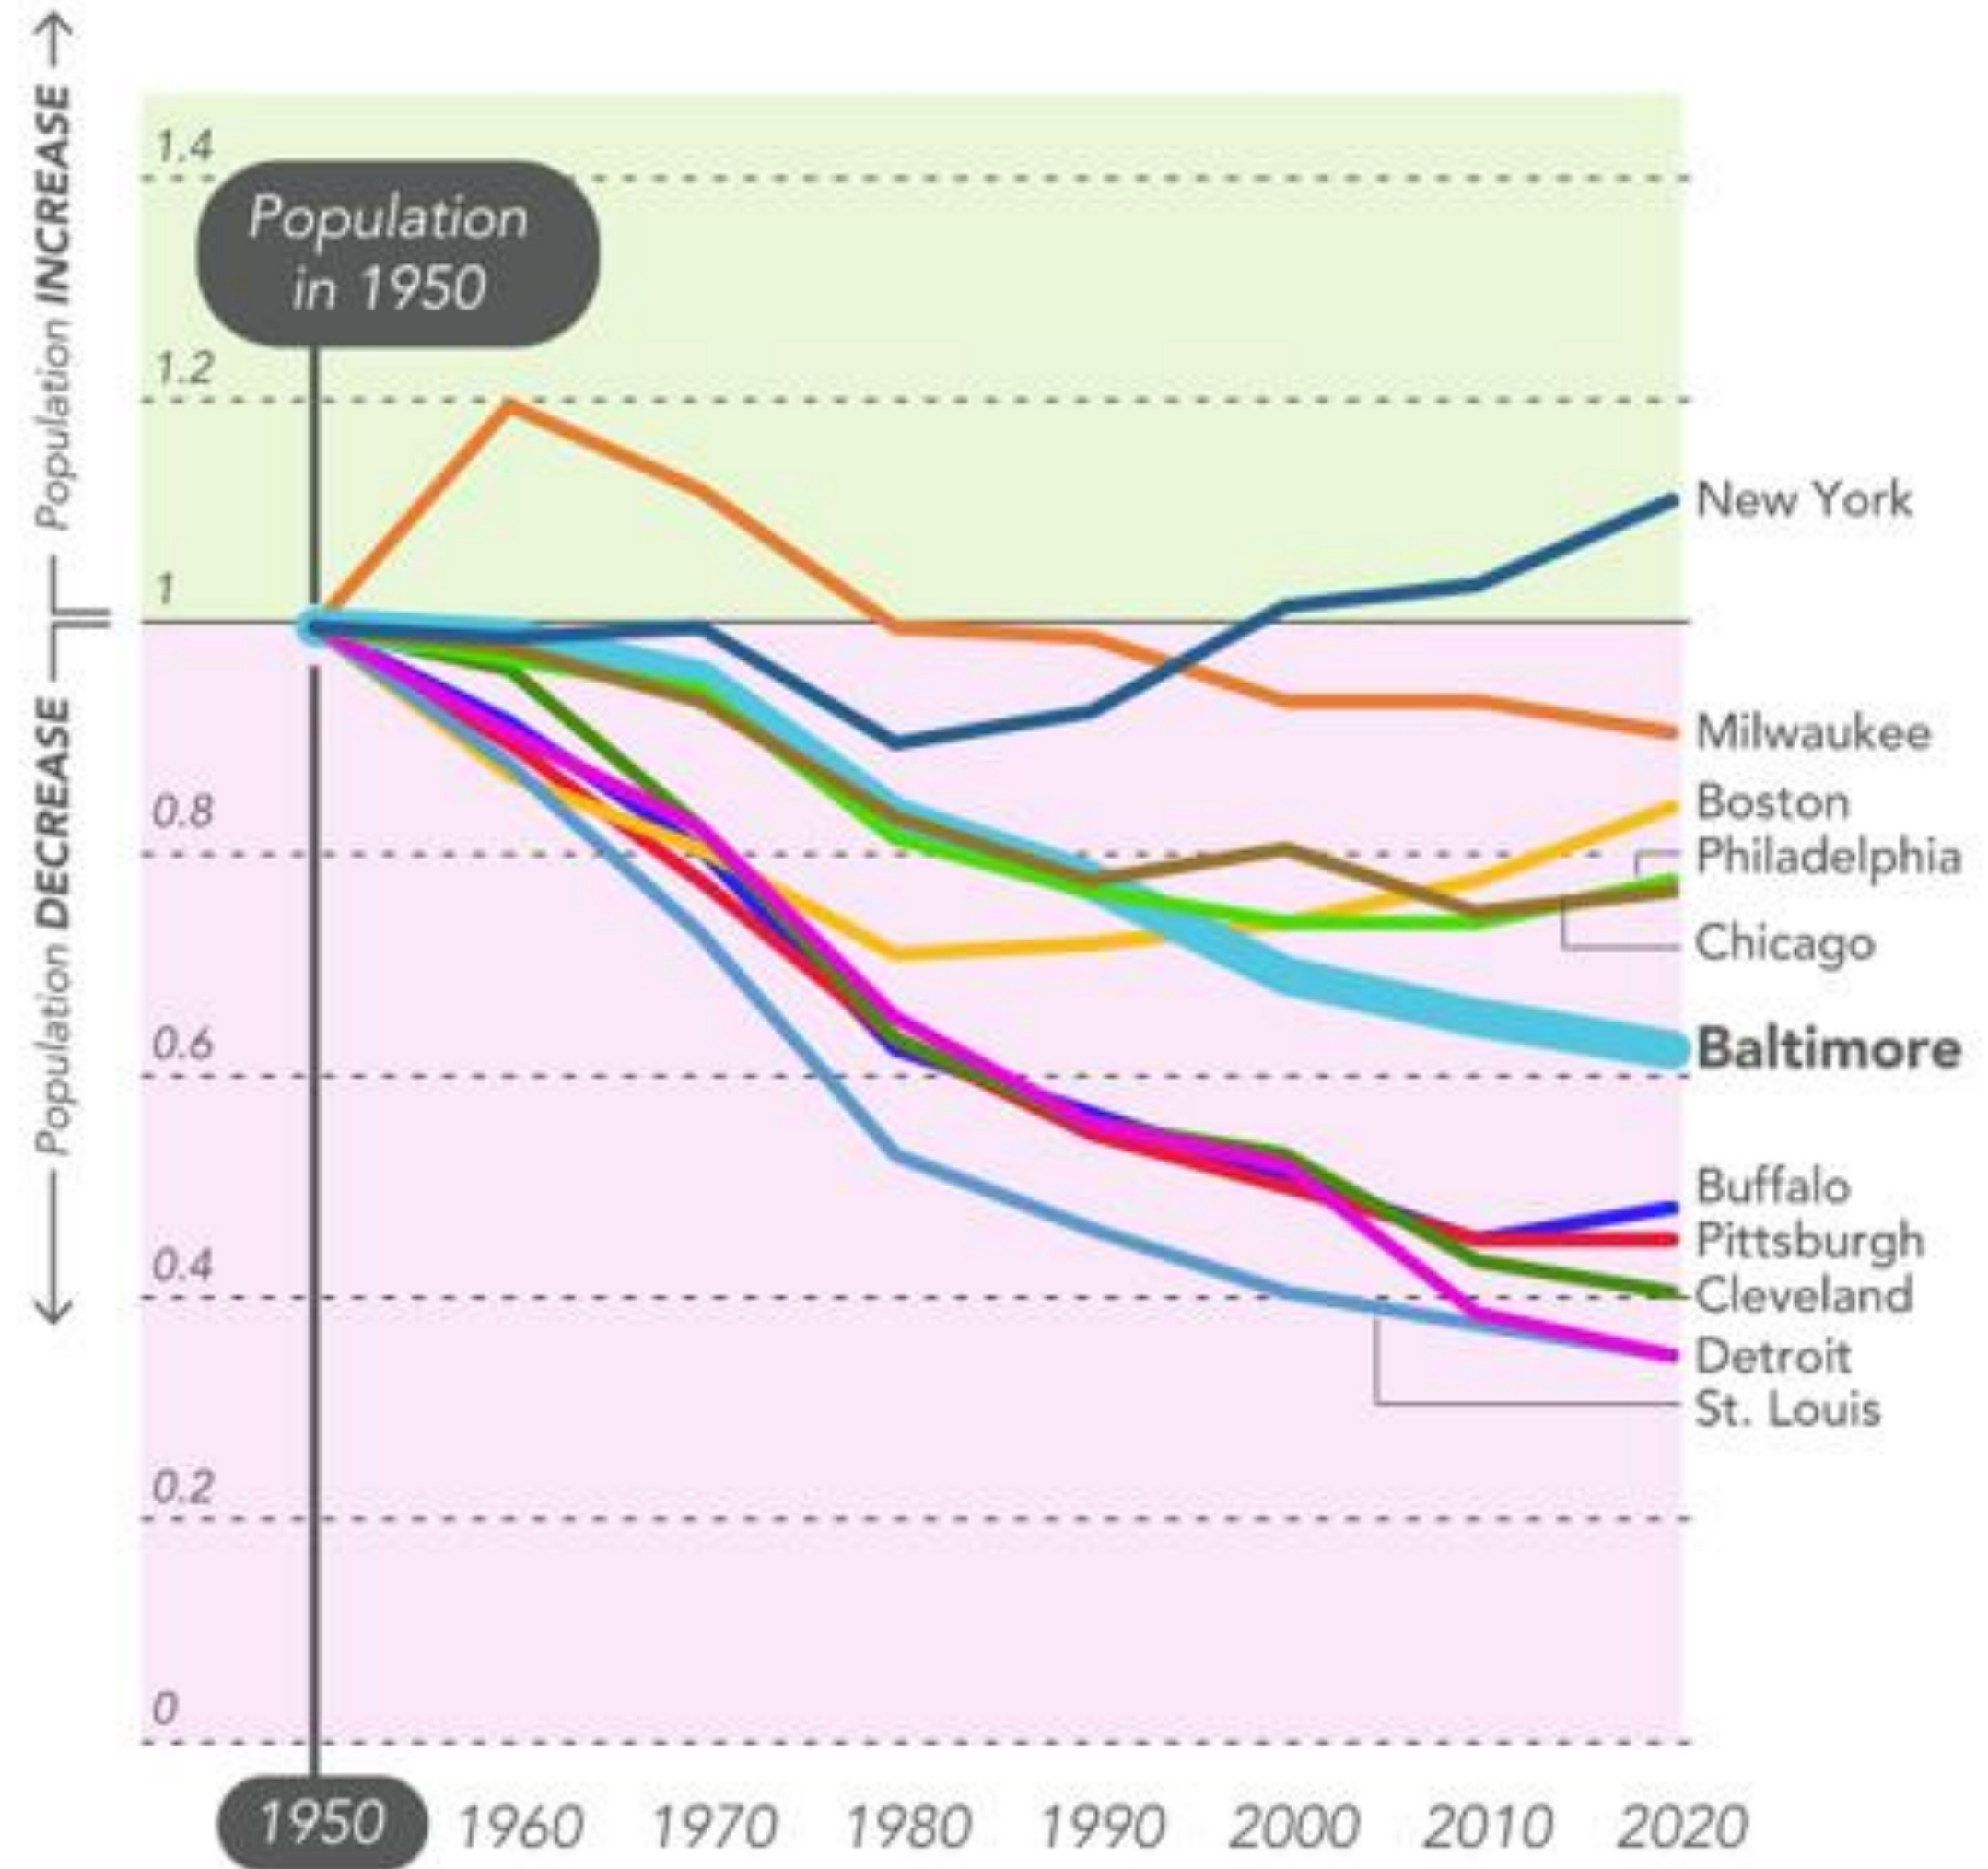
### Population change since 1950 in Baltimore and major industrial peers

- Due to population decline and disinvestment in Baltimore City, vacant housing is prevalent

Source: U.S. Census Bureau, Decennial Census; all cities presented had 500,000 or more residents in 1950 and were manufacturing hubs

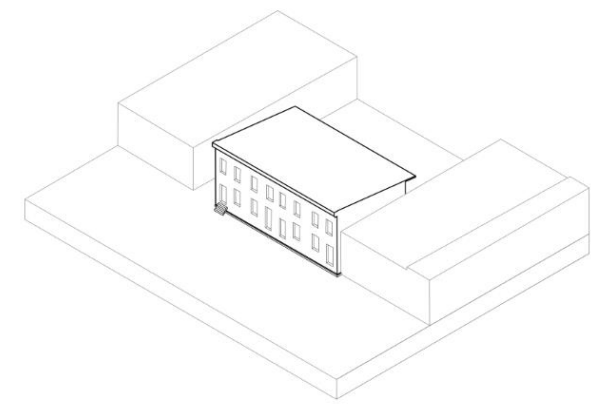
**Four individual pre-existing unoccupied rowhomes**

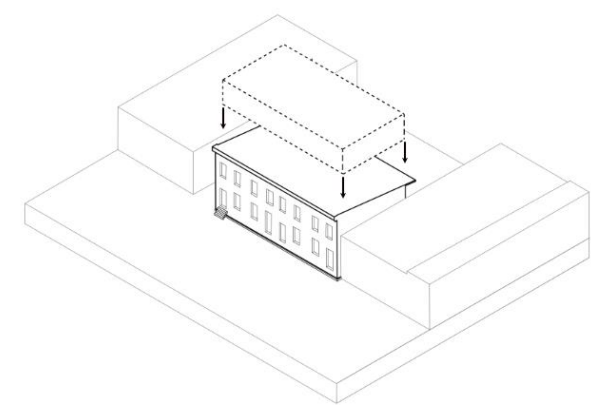
**Addition of third level to pre-existing structure**

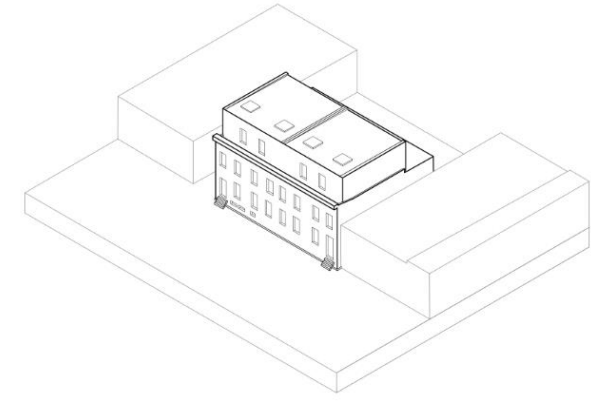
**Completed two-unit individual family rowhomes**

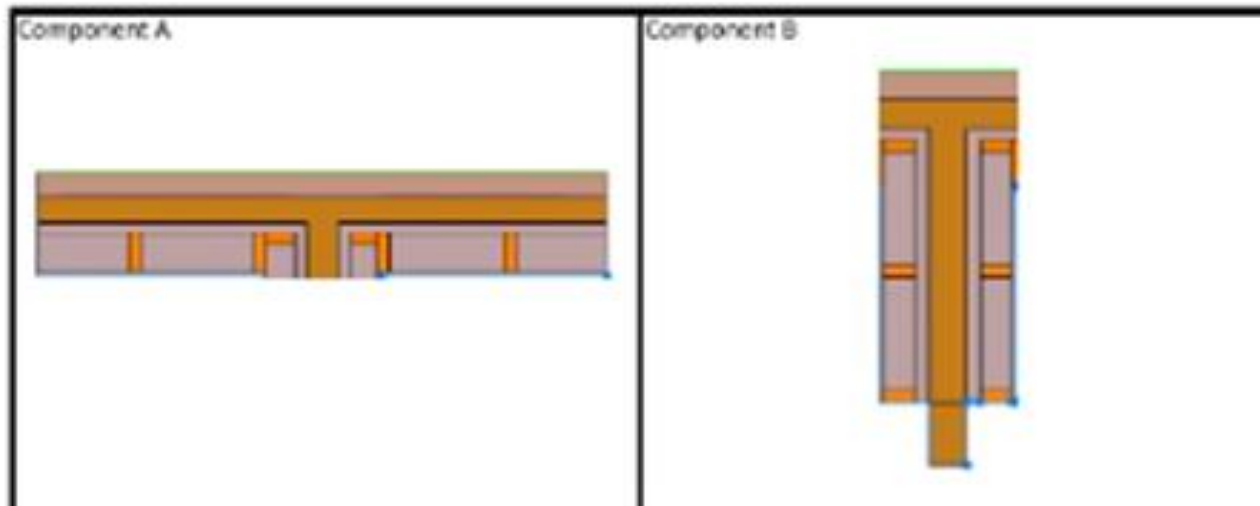
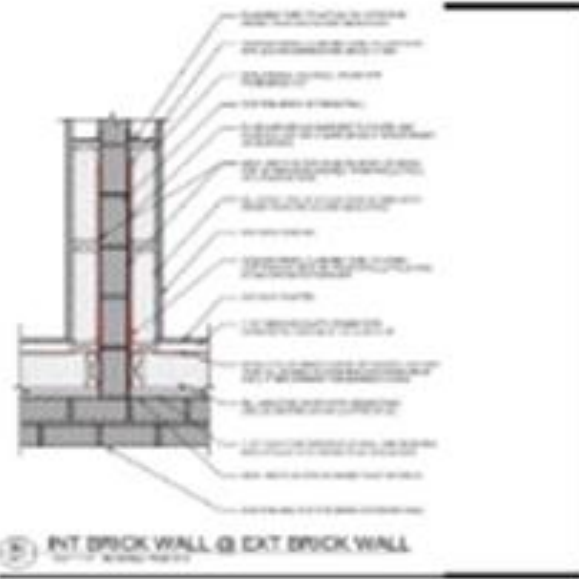
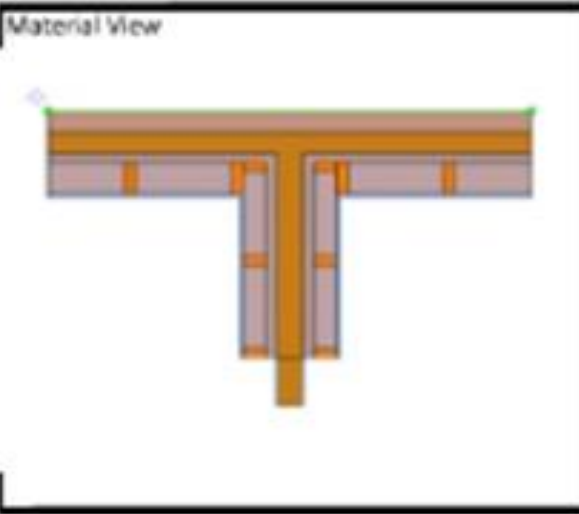
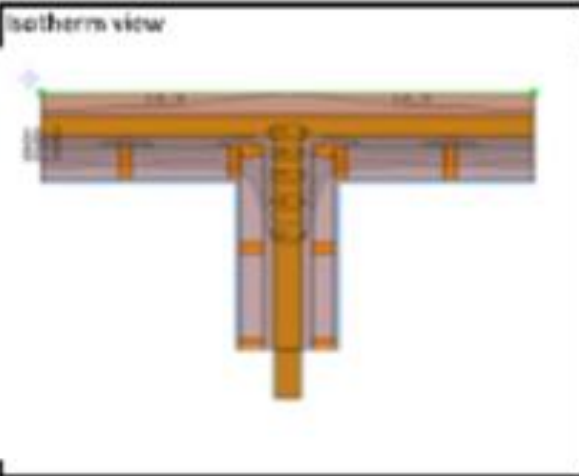
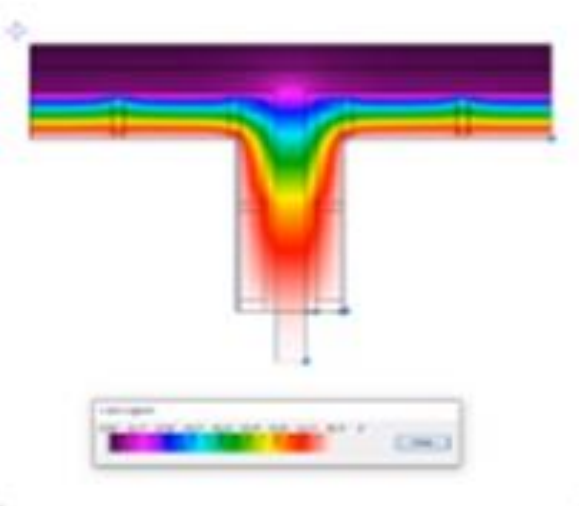
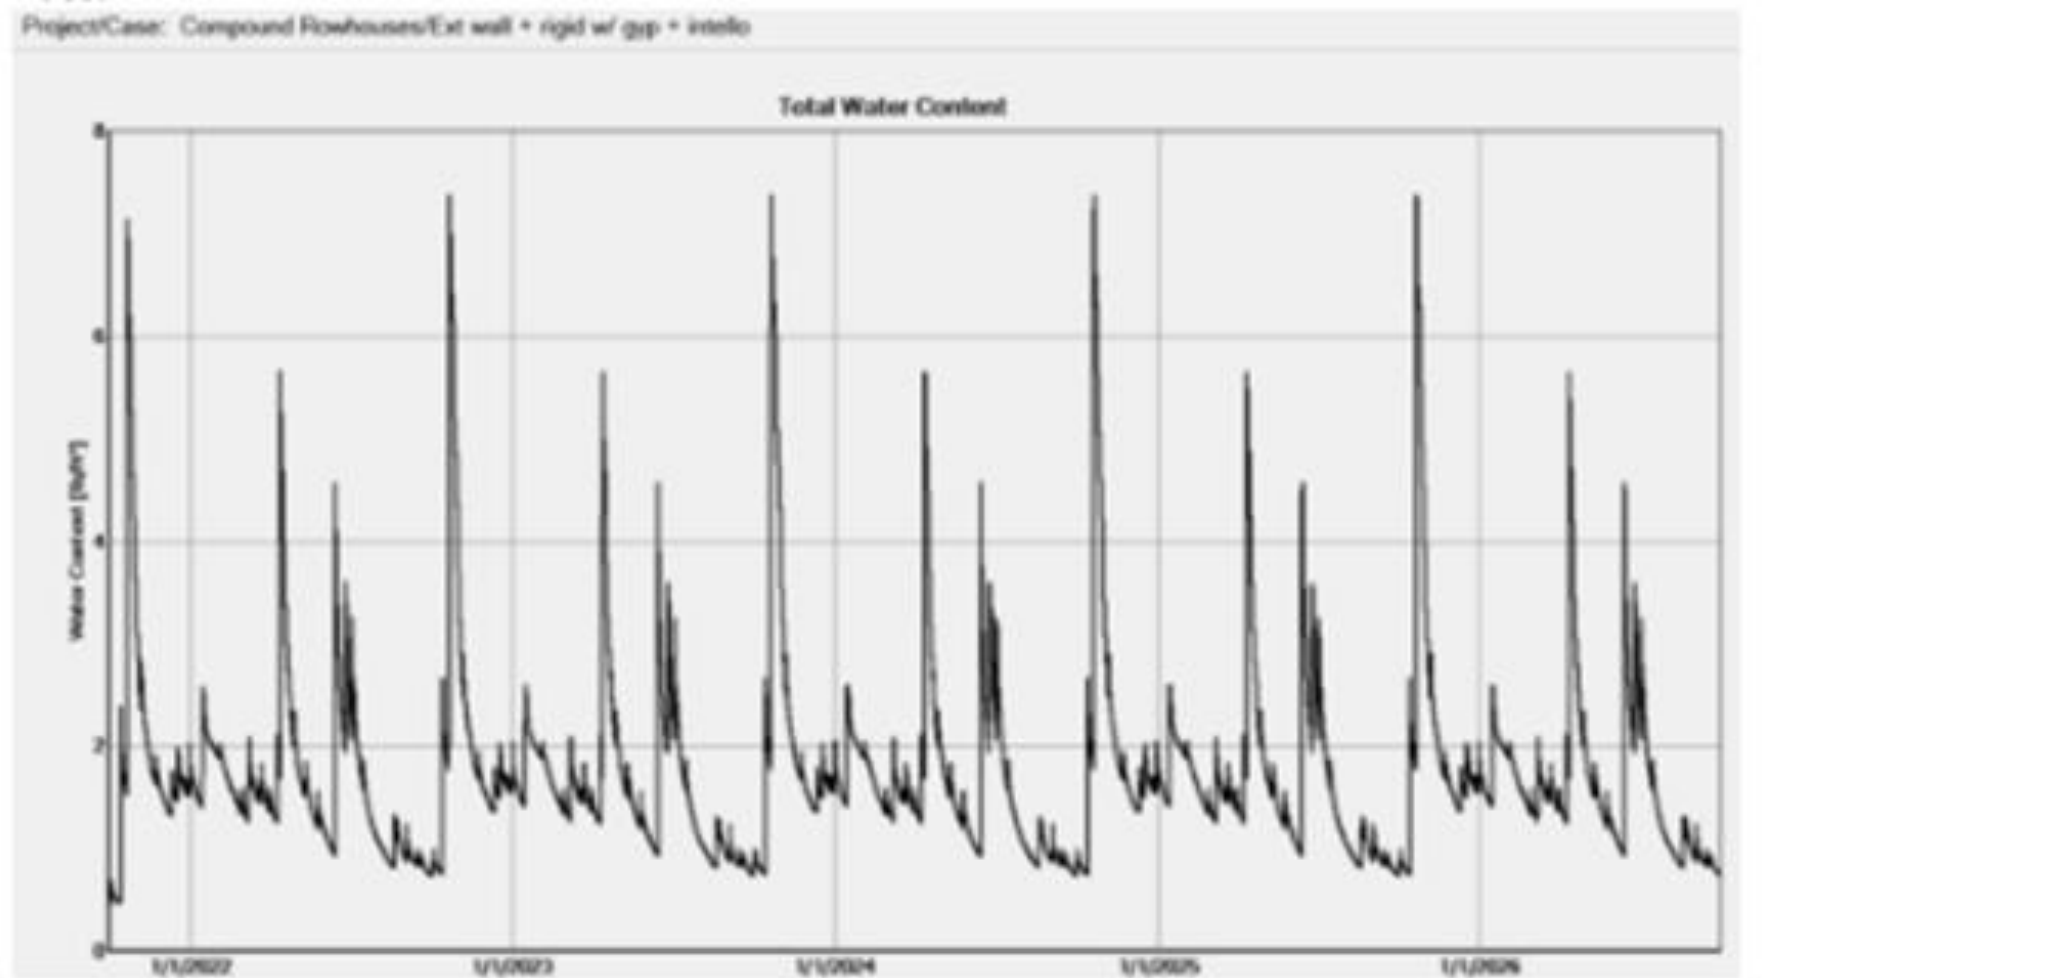
# PHIUS+ Thermal Bridging Psi-Value Calculator & Report v2.2

Description: **Wall 1XF6 at old rowhouse party wall**

T (F)	Surface Film Resist. (R-Value)
<b>Indoor</b>		
Wall Ex.	68	0.74
Roof Ex.	68	0.57
Floor Ex.	68	0.97
<b>Outdoor</b>		
Ambient Ex.	14	0.23/0.45
Ground Ex.	41	0

U (btu/hr.sq.ft)	dT (F)	L (in)	ULdT (btu/hr.ft)	error (%)
Interior	0.0285	54	189.00	17.70	1.60%
Exterior	0.0285	54	72.00	9.17	1.60%

Component	U (btu/hr.sq.ft)	dT (F)	L (in)	ULdT (btu/hr.ft)	error (%)
Component A	0.0444	54	62.50	12.49	1.49%
Wall 1XF6	0.044	54.00	62.50	12.49	1.49%
Component B	0.0782	0	35.5	0.00	1.49%
Interior Old Party Wall	0.0782	0.00	35.50	0.00	1.49%

PsidT (btu/hr.ft)	dT (F)	Psi (btu/hr.ft)	Psi for WUFI (btu/hr.ft)
Interior	5.21	54.00	0.097	<b>0.018</b>
Exterior	-3.32	54.00	-0.061

Average psi value is too far off from individual interior and exterior values, please check yellow inputs or use the complete psi value calculated in cell B4 or B5.

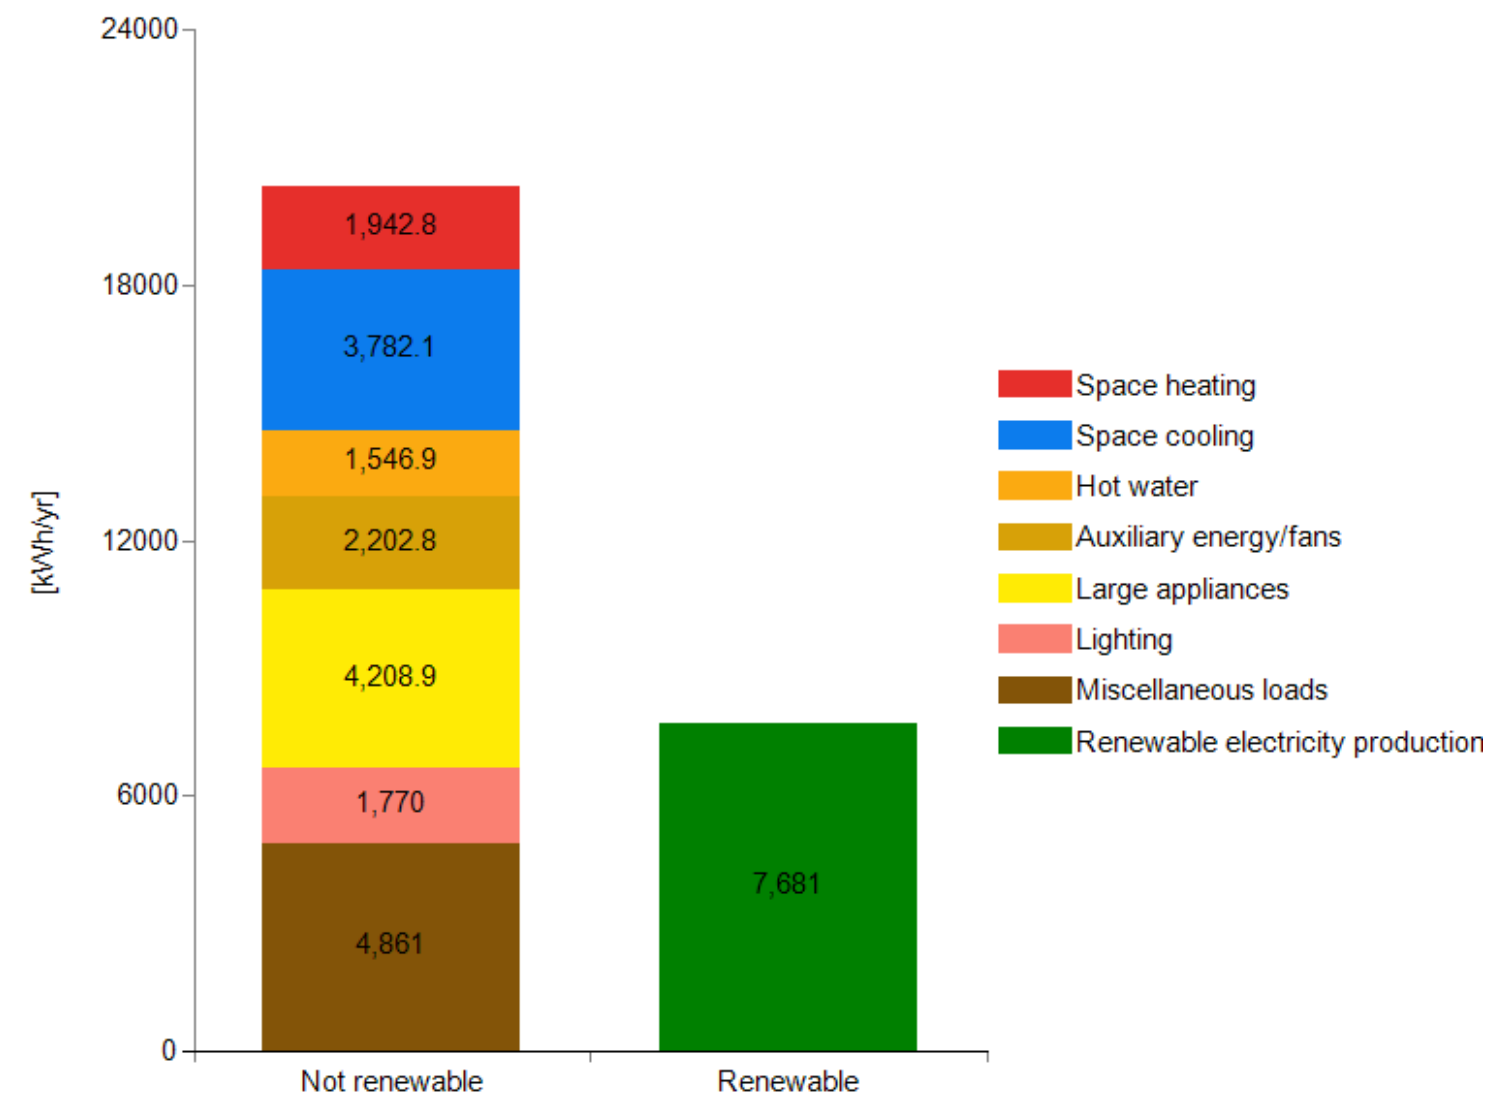
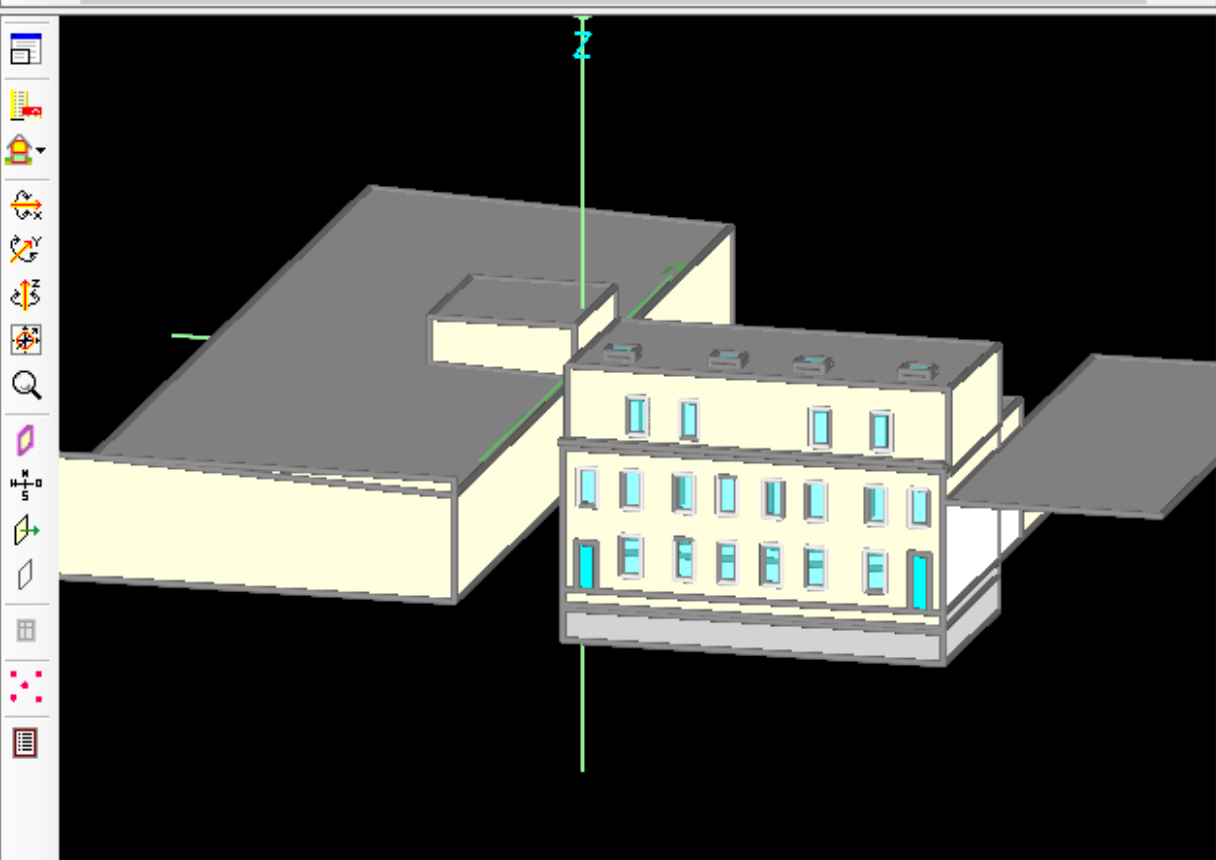
### OVERVIEW

Heating demand:	4.28 kBtu/ft²yr	0 1 2 3 4 5 6 7 8 9	✓
Cooling demand:	6.46 kBtu/ft²yr	0 1 2 3 4 5 6 7 8 9	✓
Heating load:	3.91 Btu/hr ft²	0 1 2 3 4 5 6	✓
Cooling load:	2.98 Btu/hr ft²	0 1 2 3 4 5 6	✓
Source energy:	3,537 kWh/Person yr	0 2000 4000 6000 8000 10000	✓
Site energy:	8.36 kBtu/ft²yr	0 1.5 3 4.5 6 7.5 9	✓

**8.4**  
Kbtu/sf/  
yr

**83%**  
2030 savings

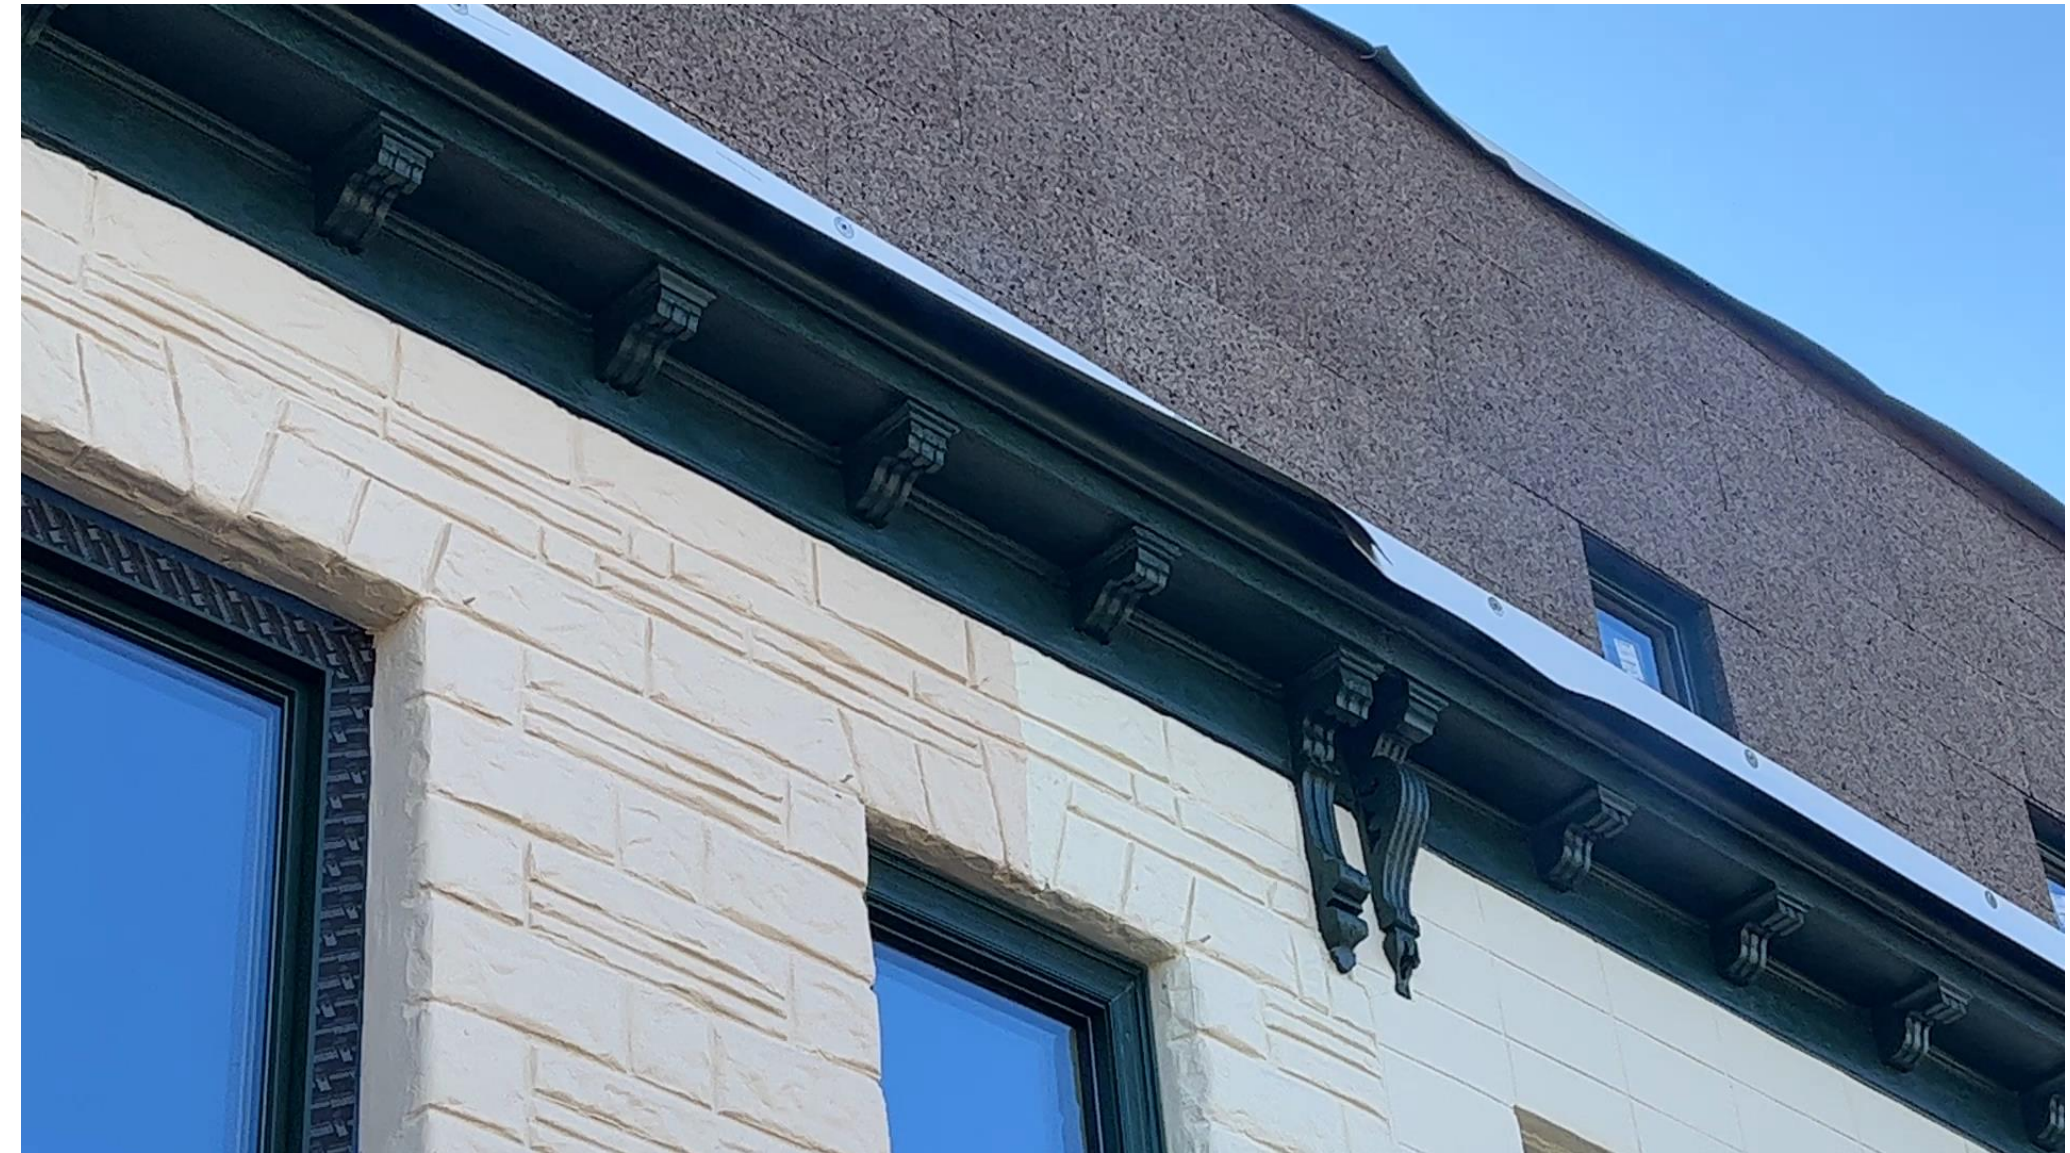
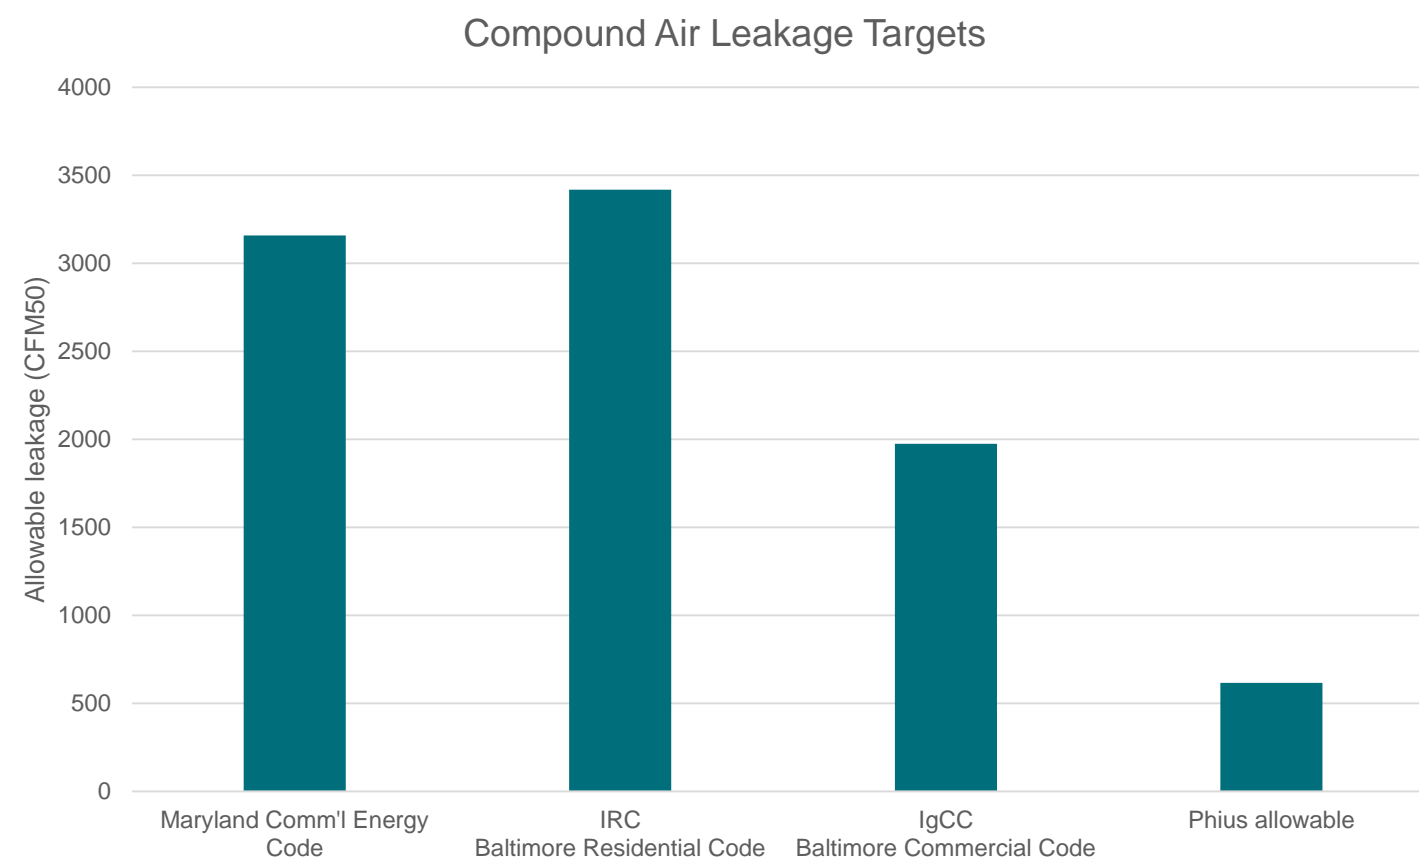
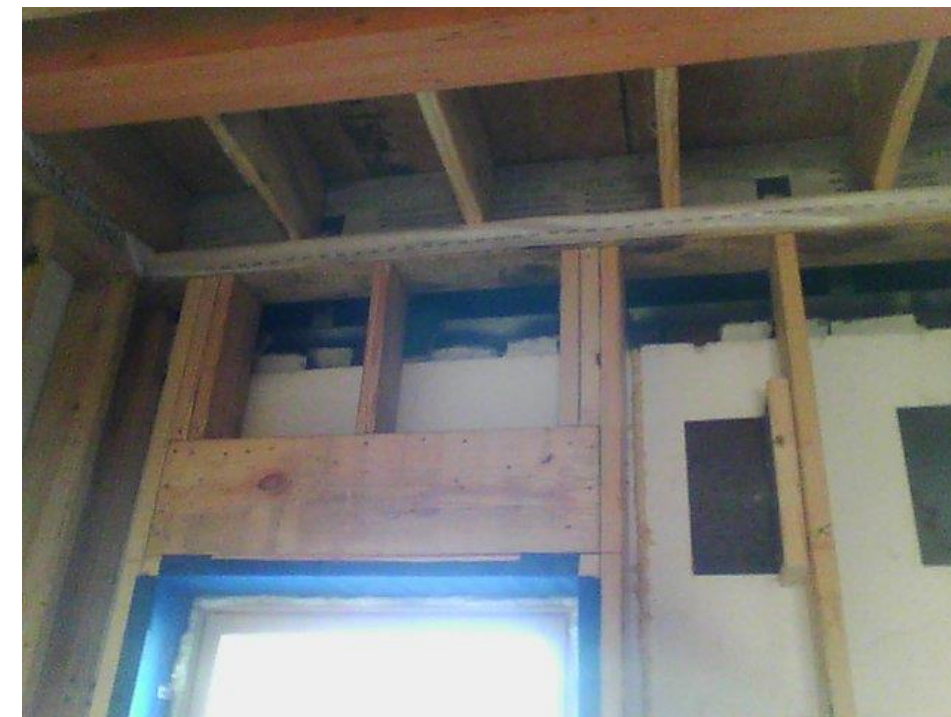
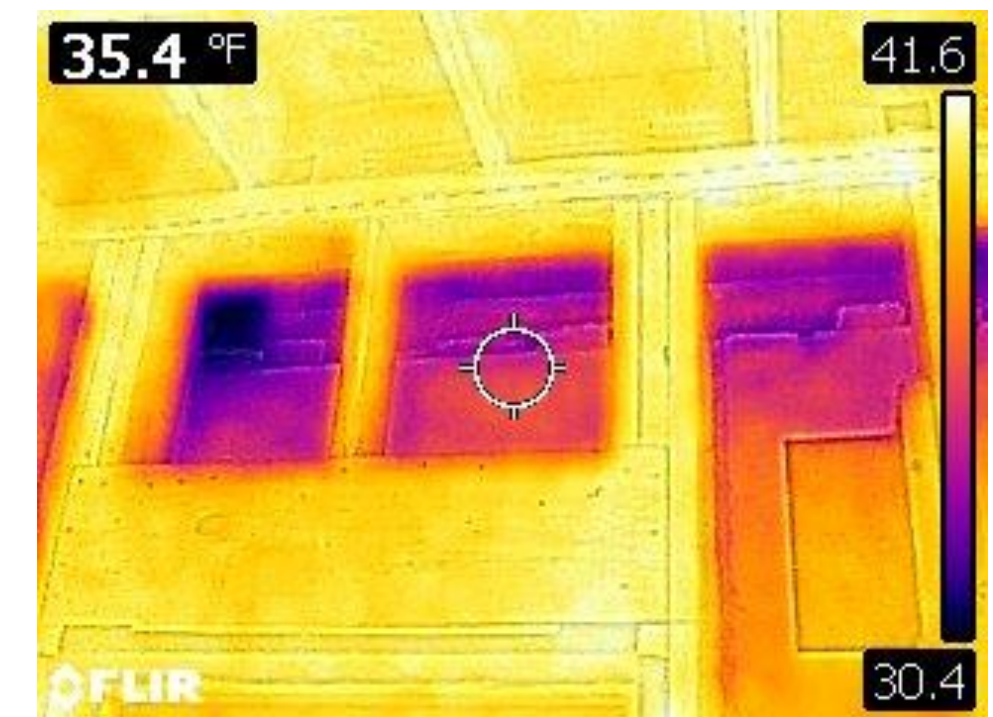
# Cornice

- The existing wood cornice detail proved to be a large source of air leakage during the midpoint blower door test, and complicated hitting the strict Phius air leakage target.
