# The Compound Rowhouses

Palimpsest: Layering Thermal Control into an Existing Building

NEW ECOLOGY

QUINN EVANS

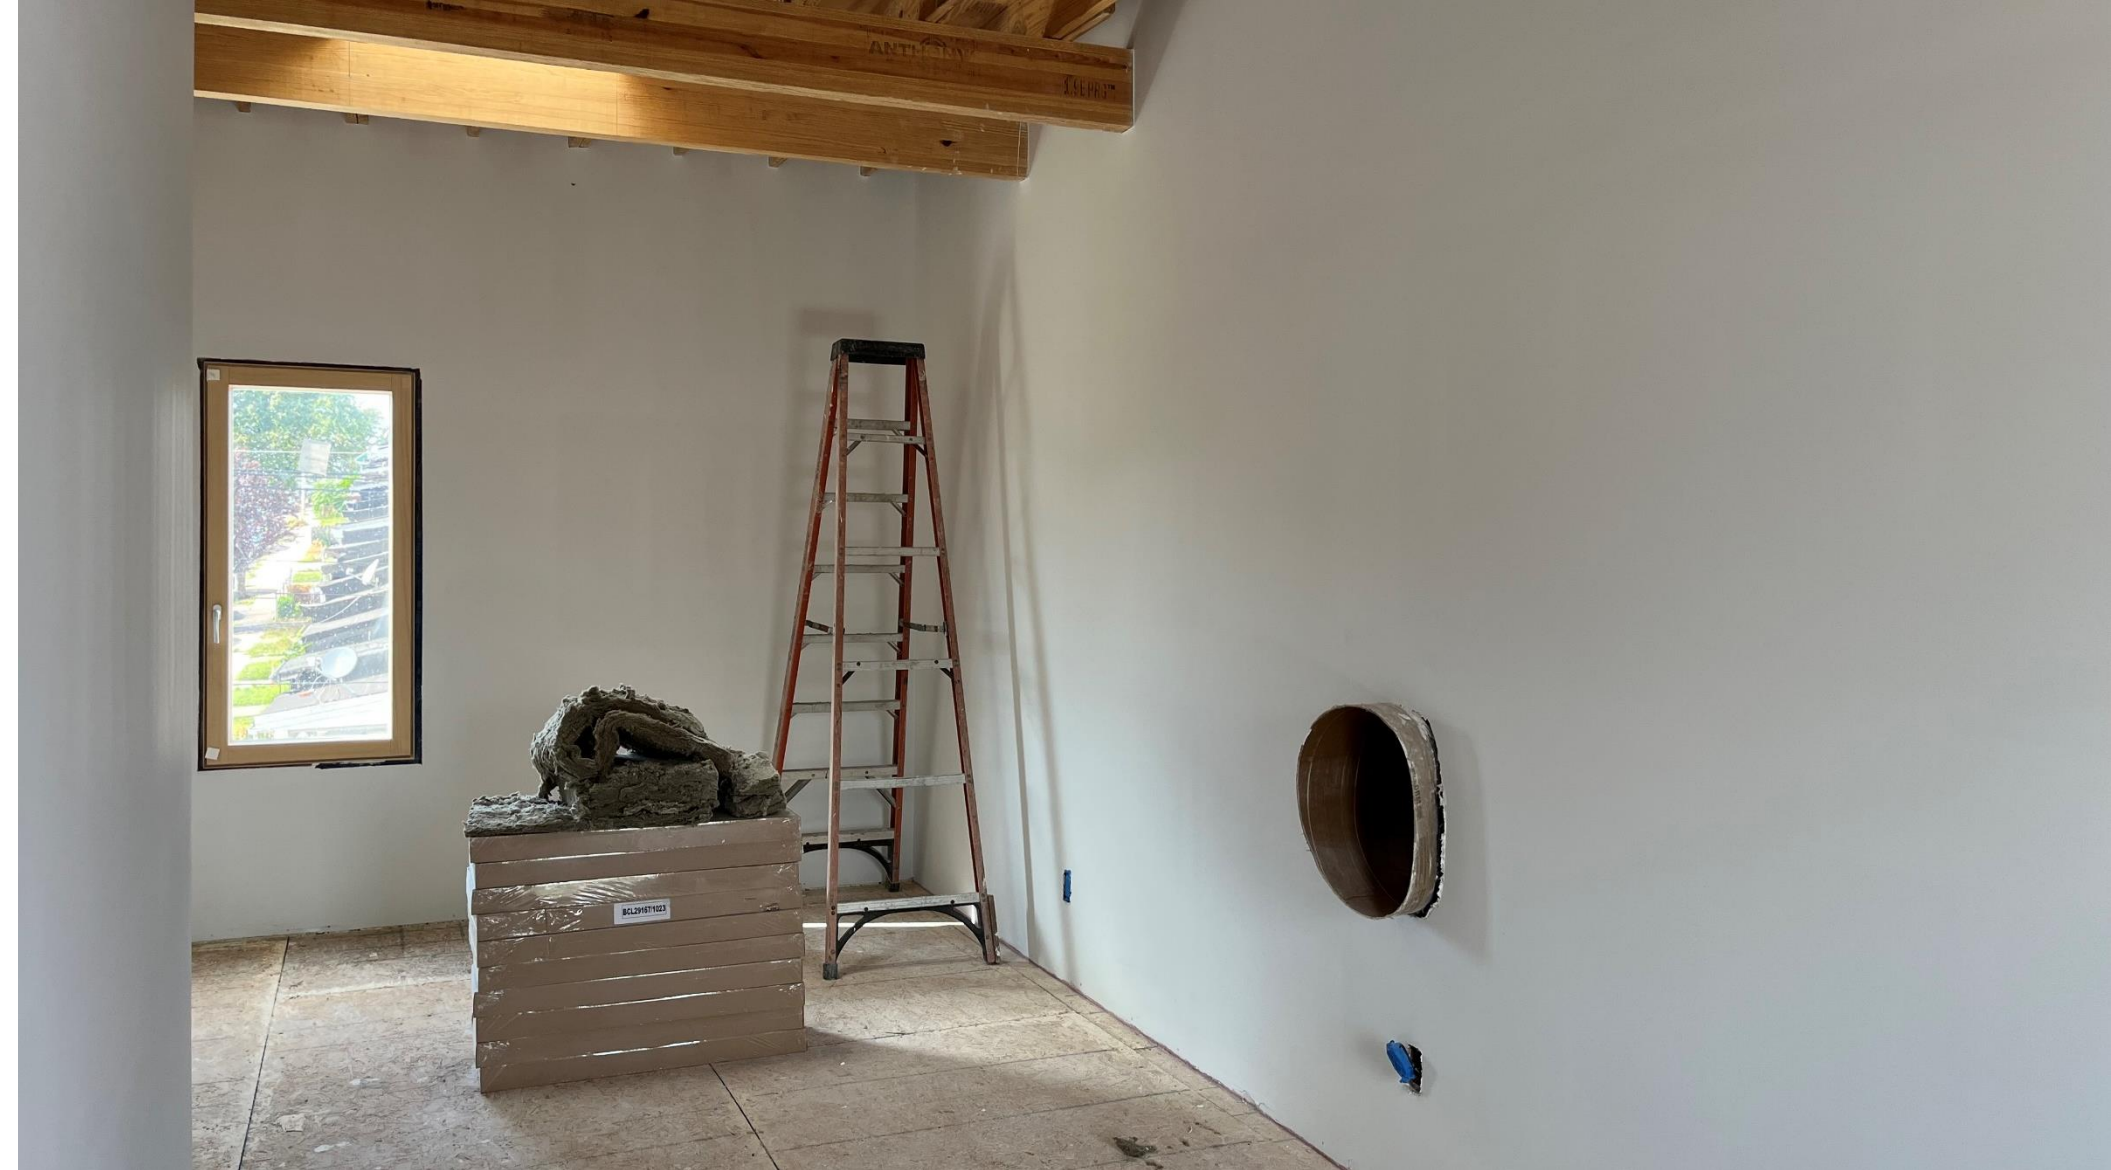
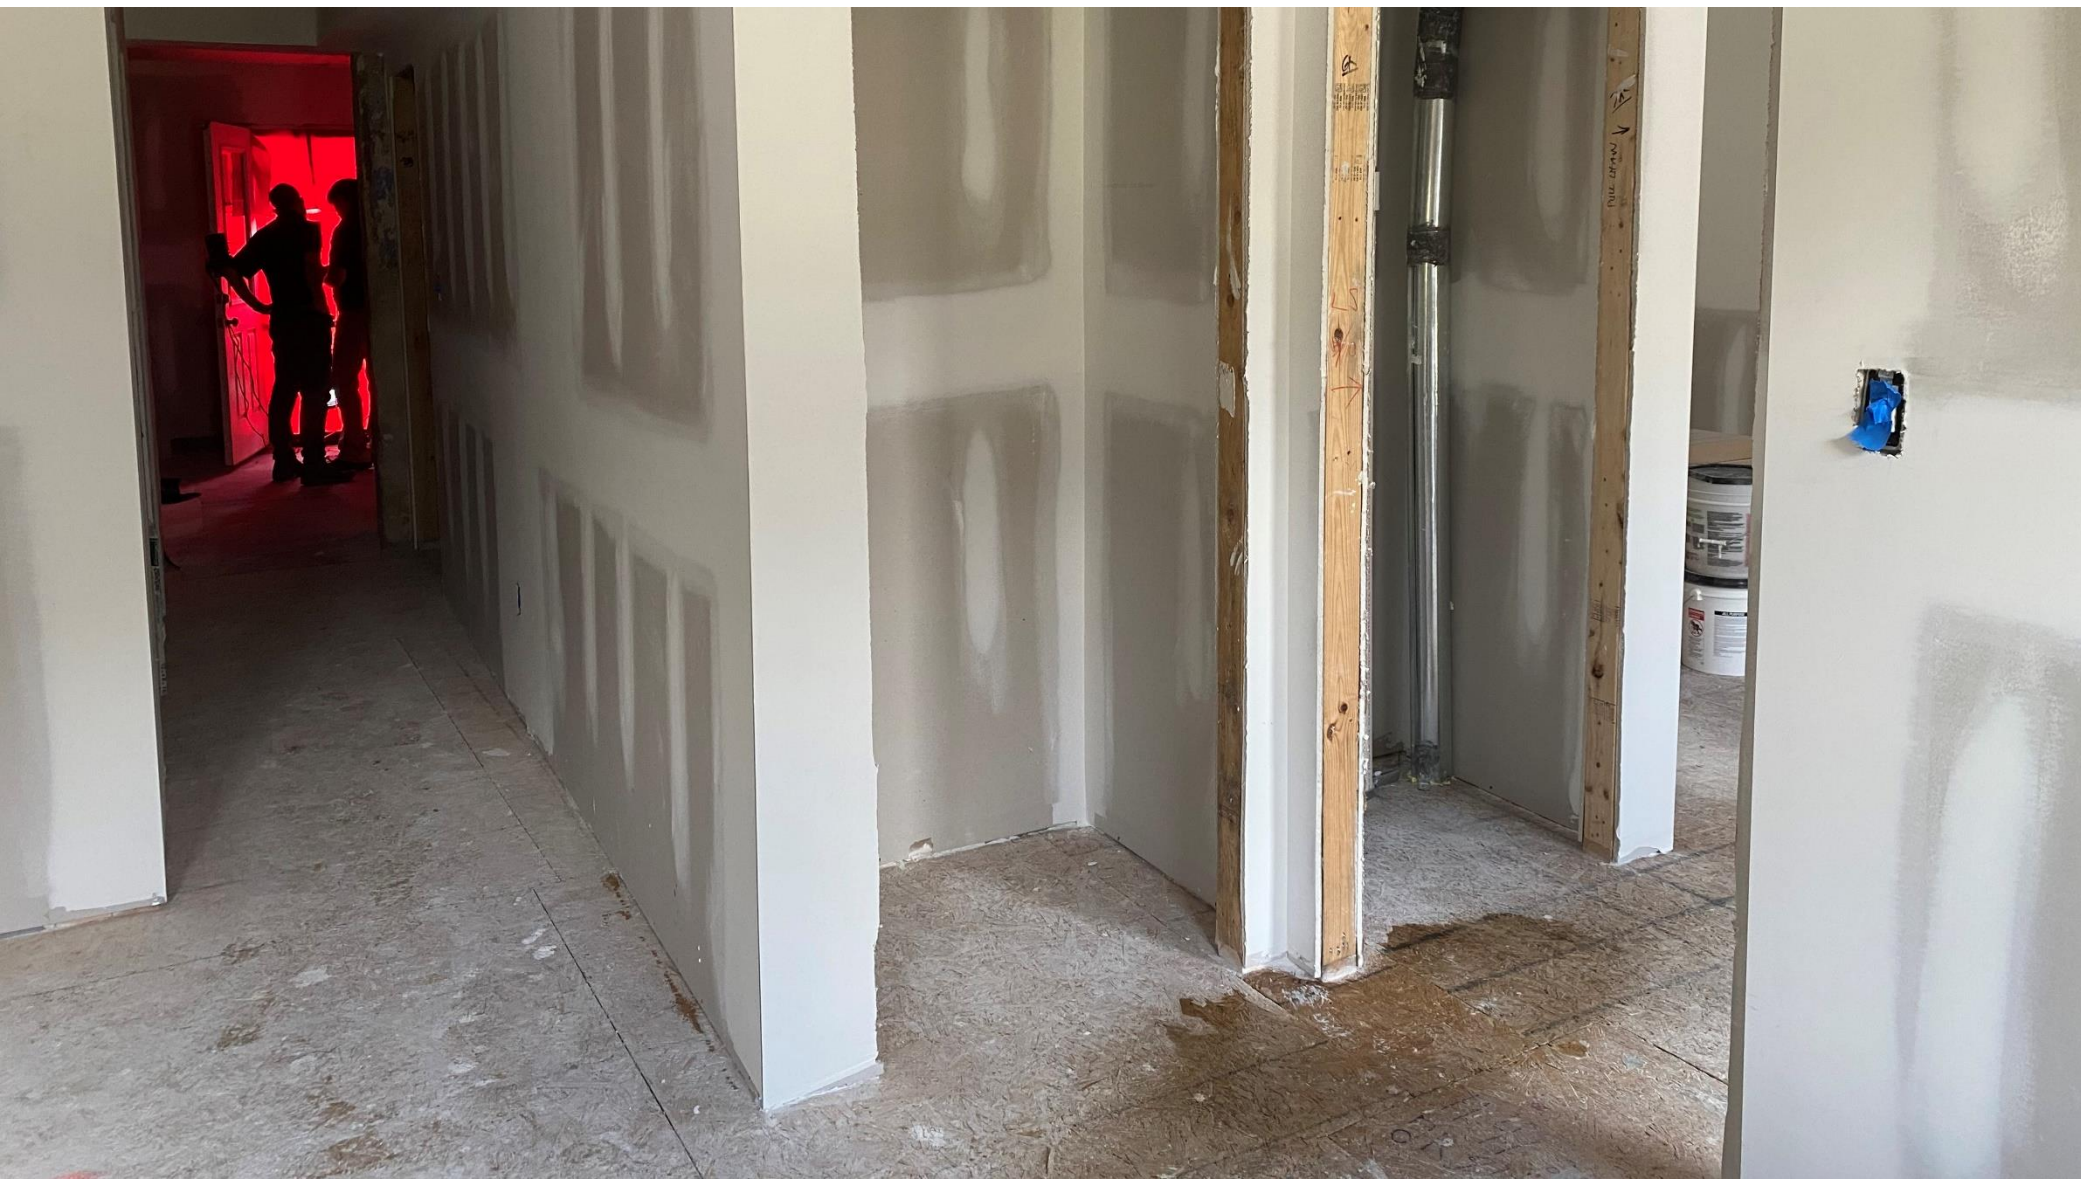
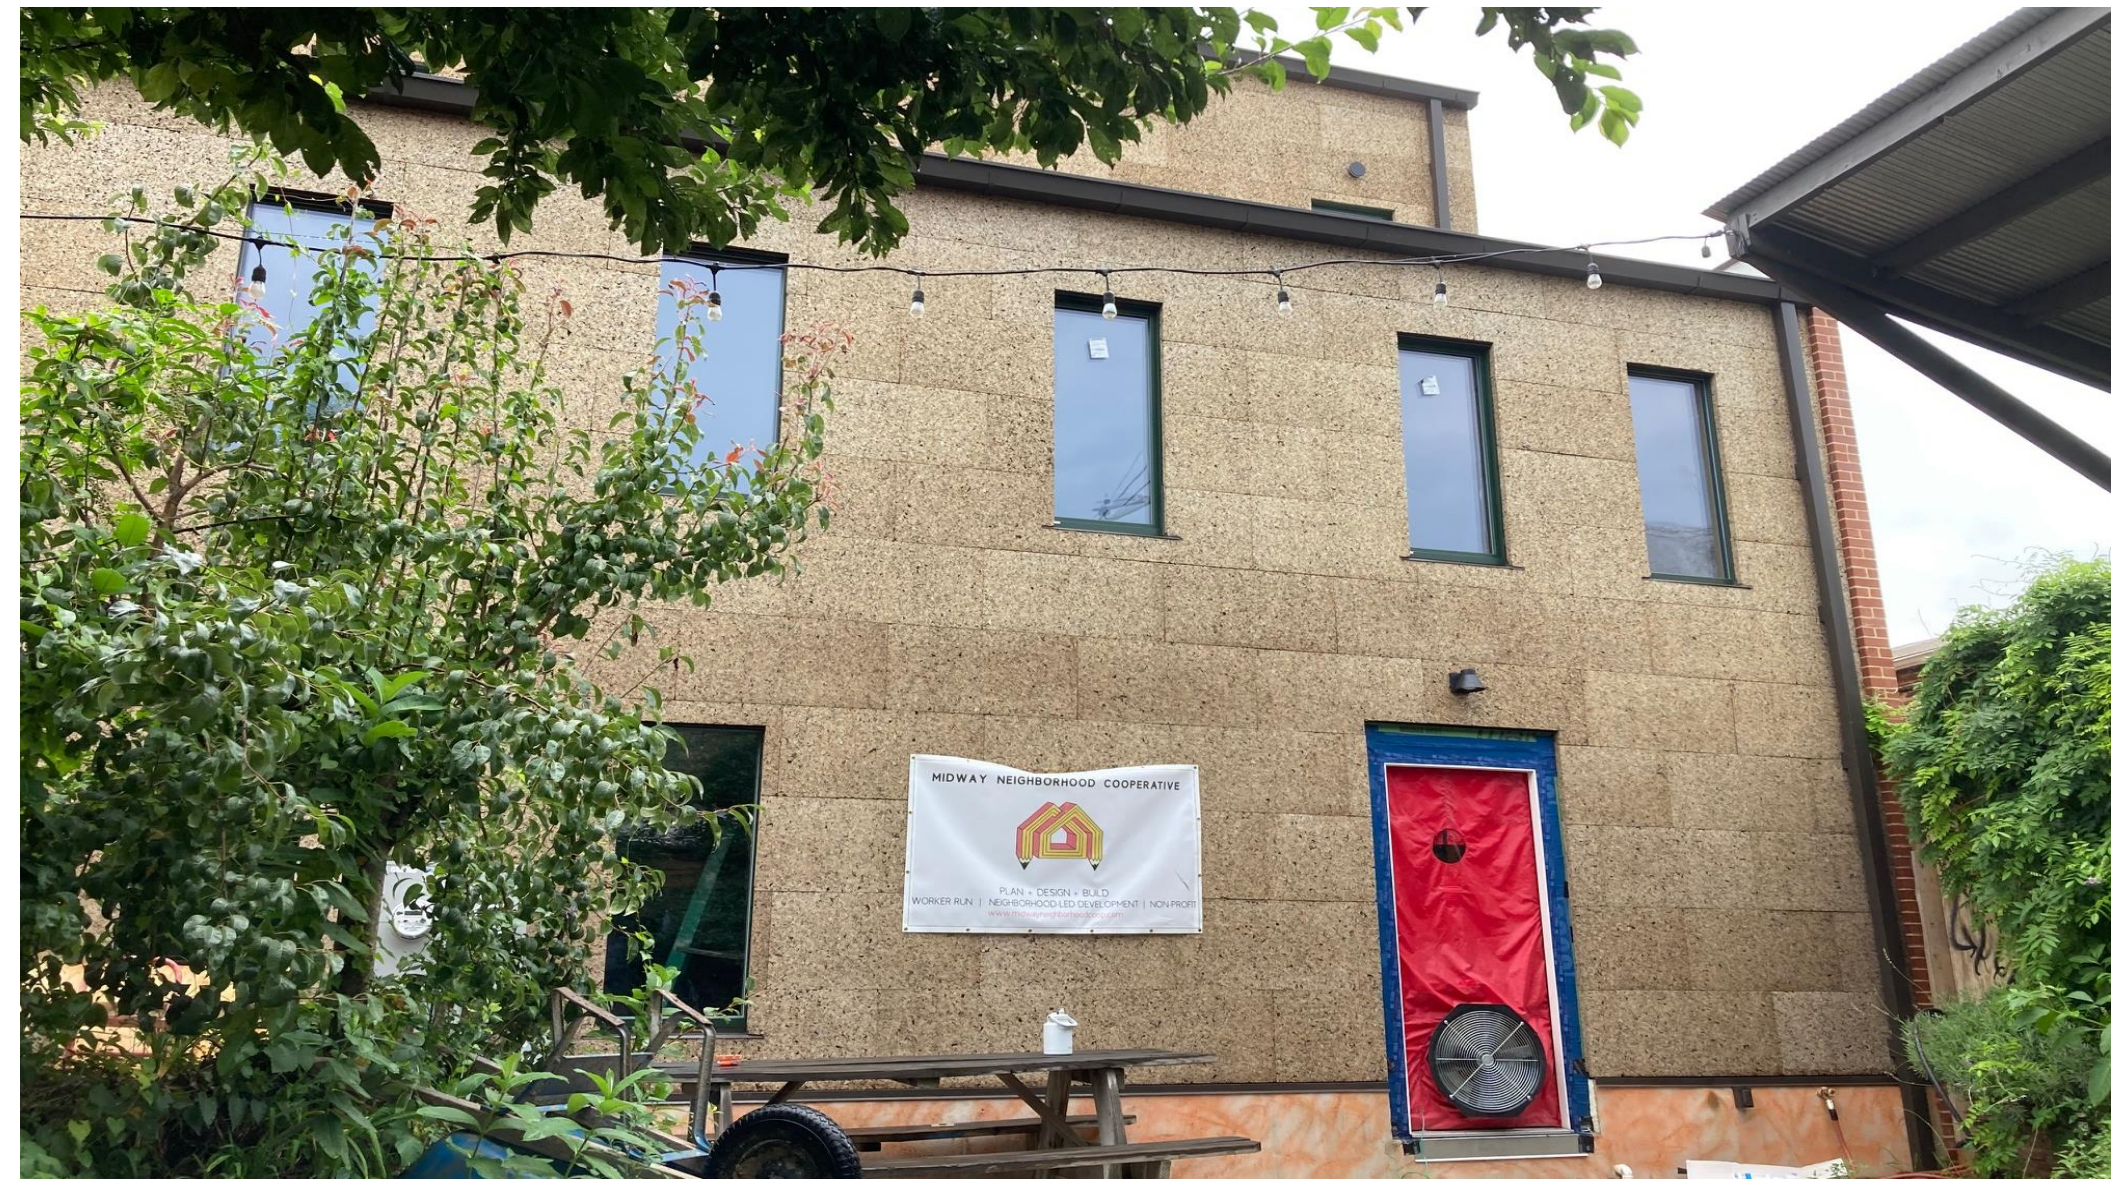
# Aerobarrier & Doors

- Despite the team's best detailing and air sealing, the target CFM50 value was still slightly out of reach.
